Coatings for Biogas Applications:

## Restoration of ensilage tank with Proguard CN-1M – effective protection against chemical influences and abrasion

**Project:** Refurbishment of a concrete tank for biogas ensilage

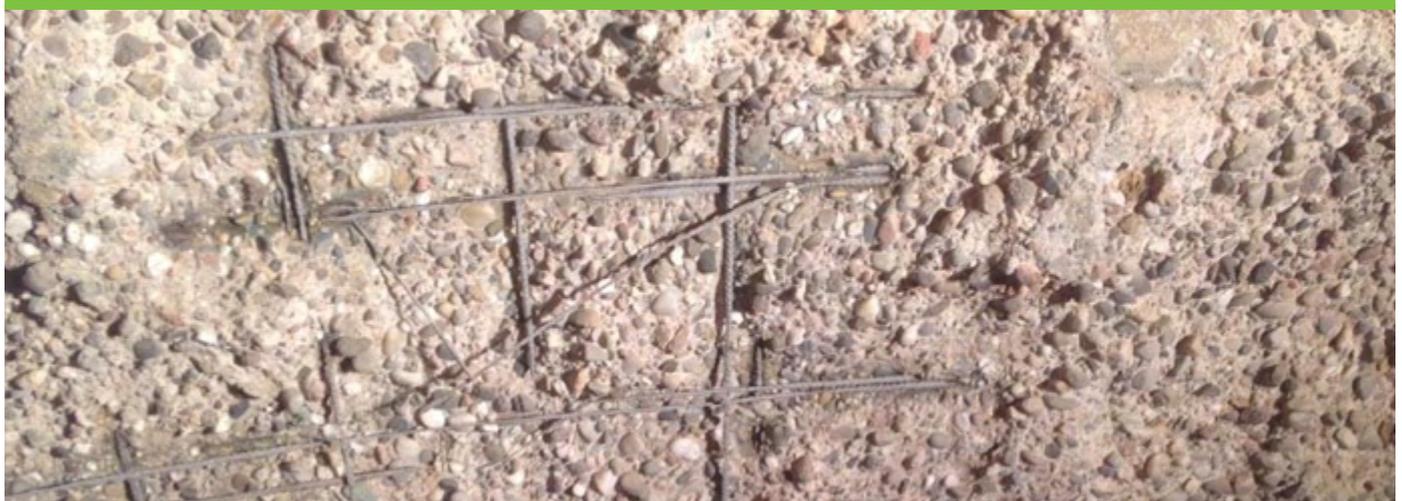
Extreme concrete erosions, induced by biogenic sulfuric acid attack (BSA)

The ensilage tank showed advanced concrete erosions down to the steel reinforcement, induced by biogenic sulfuric acid attack (BSA). Thus, the steel was exposed to high corrosion risk; immediate action was required.

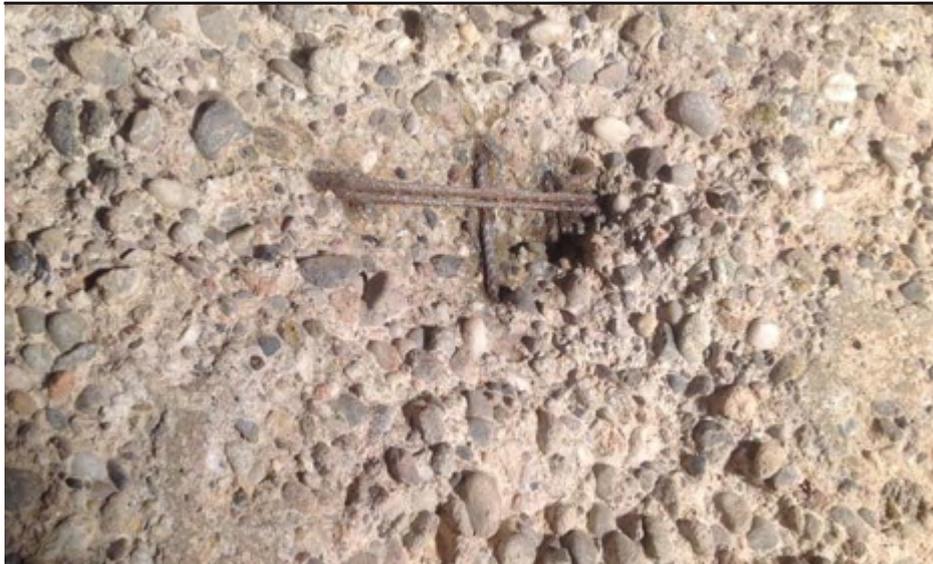
It is a fact; uncoated concrete does not suffice for long-term operation against chemical attack! Through the microbiological decomposition process and the acidic environmental conditions ensilage, biogas and biomass cause an extreme chemical load for the concrete substrate. A high performance coating is required to protect against serious concrete damage.

"Washed-out-concrete-effect" - caused by aggressive acids in the ensilage

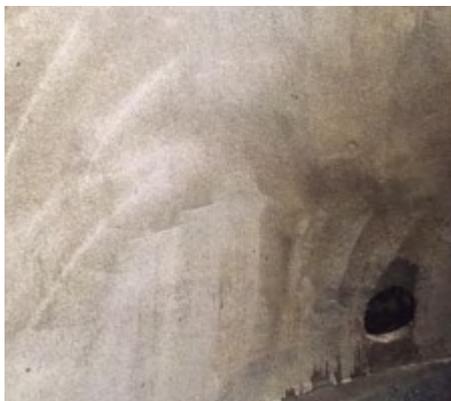
Primed wall area, sprinkled with quartz sand

Afterwards the walls were undercoated with our concrete-primer CP-SYNTHOFLOOR BETA 8016 and lightly sprinkled with quartz sand to achieve an anchorage profile for the protective coating.

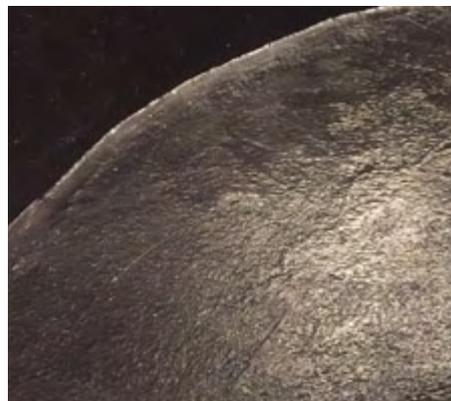
Coated wall and floor

The application of the high-grade chemically resistant coating PROGUARD CN-1M was conducted by airless spraying in a single layer with a thickness of 600 µm. One application procedure is enough to accomplish a reliable protection against aggressive chemical attacks and abrasion damages.

The further process within this extensive restoration was the floor treatment. The repaired concrete was also primed and sprinkled with quartz sand. In this area our product PROGUARD CN-1M was easily applied with a rubber squeegee.

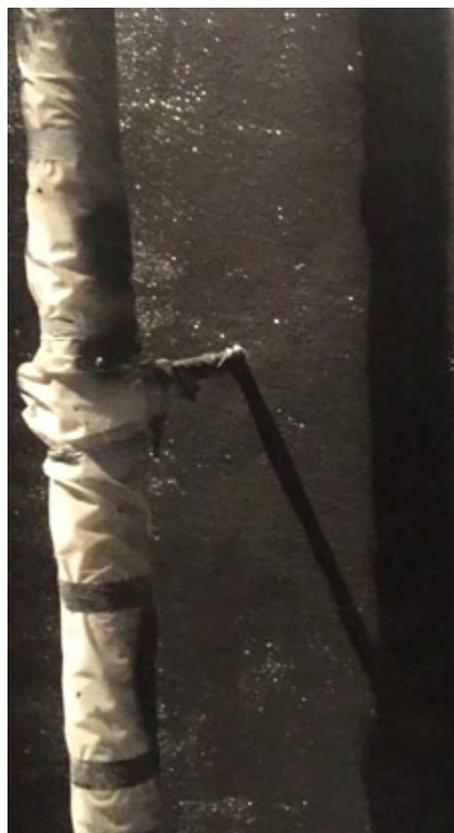
Coated wall area
