Coatings against Bio Corrosion:

What is Anaerobe Bio Corrosion (MIC)? How destroy SRB bacteria steel and concrete?

Ceramic Polymer GmbH
Daimlerring 9
D-32289 Roedinghausen

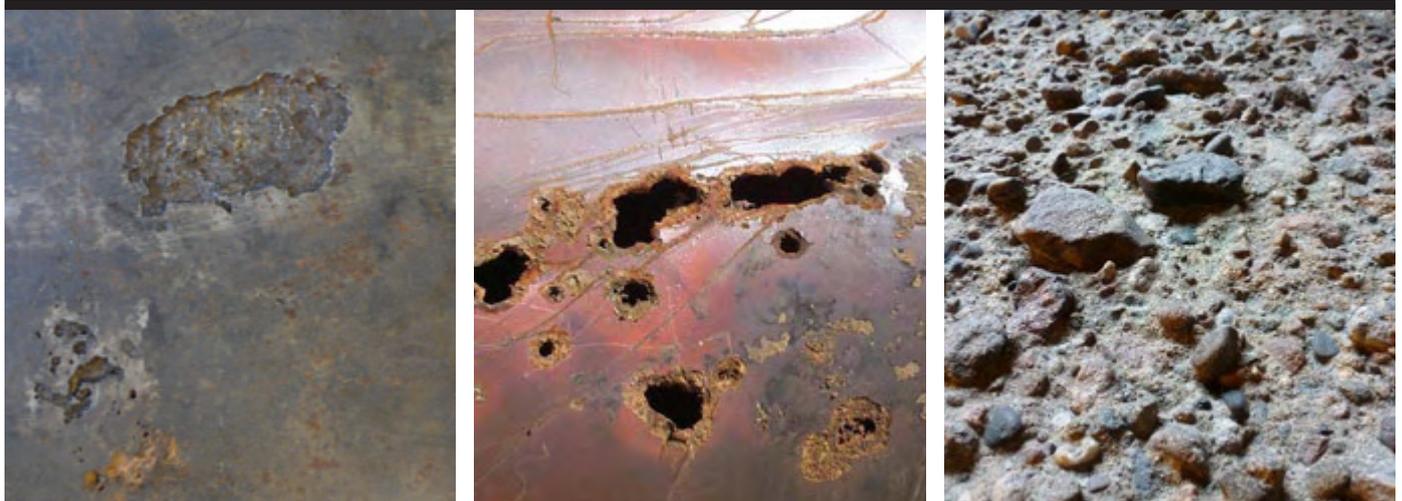
Advanced biocorrosion, pitting corrosion and extreme concrete erosions; induced by microbial metabolic products (release of special enzymes and hydrogen sulfide)

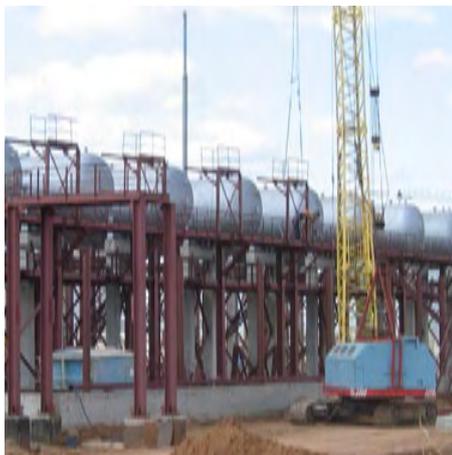
Crude oil separators, internal coating against SRB bacteria

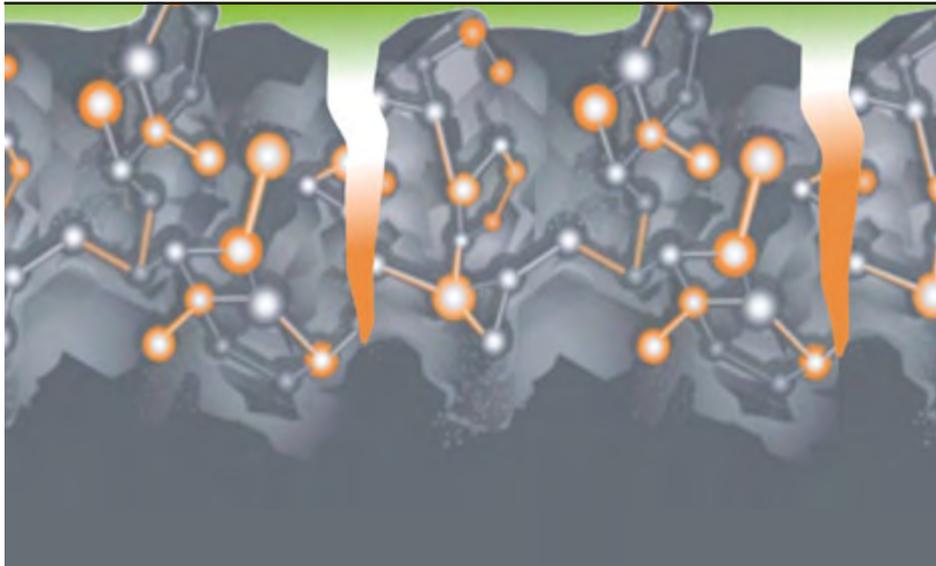
Picture: Effect of the new tank lining products. As soon as micro cracks occur in the coating, the special biocide crystals burst and unfold their effect within the whole crack. The SRB are killed before their settlement. The existing depot effect causes a long-lasting biocidal corrosion protection without localized erosion.

The description of the bio corrosion processes shows that it is primarily important to avoid the first population of oxygen tolerant SRB bacteria to prevent building of rust tubercles and resulting bio corrosion. The patent pending procedure of integrating the special biocide crystals into the ceramic polymer matrix destroys the SRB bacteria before they can settle in micro cracks which have occurred. Extensive test series by an independent institute has proven clearly that most thorough prevention of SRB-induced bio corrosion is provided by using our special products.
