## Coatings for Process Components

# Severe damage by pitting corrosion: Electric motor was efficiently restored with ARC- and Ceramic-Polymer-Systems

The Greek company "Hellenic Petroleum" owns a plant for polypropylene in Thessaloniki. Here, a medium voltage motor for pumps of cooling water circulation was effectively restored. The motor has been in use since 2000. It showed severe erosion and pitting corrosion damages at the impeller housing and connection box. The repair coating ARC 858(E) of our parent company A. W. Chesterton together with Ceramic-Polymer coating systems enables an efficient renewal and fast restart of the electric motor (type ATEX).

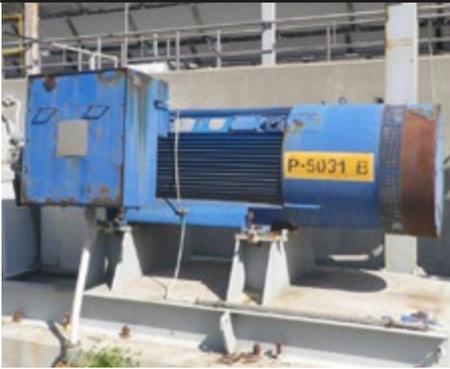
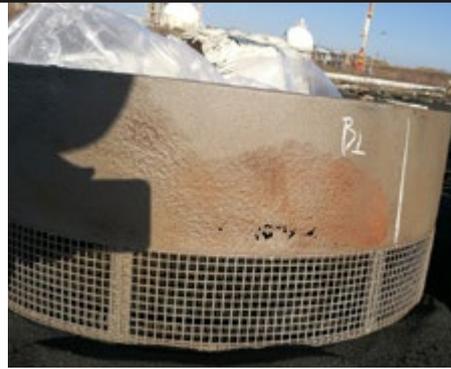
Previous condition: The whole motor showed corrosion damages. On connection box and impeller housing severe pitting corrosion occurred. 4 motors in total are installed in this plant, the first has now been renovated with our systems.

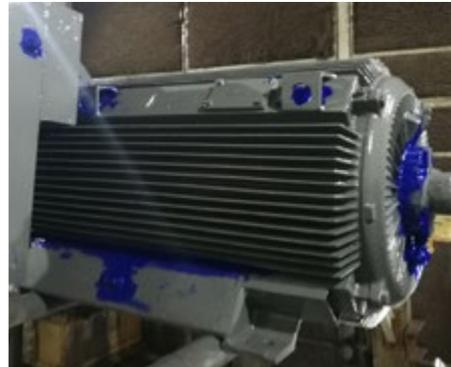
Before the protective coating was applied the surface was again sandblasted. The repaired areas were roughened by sweeping. The application of **CERAMIC-POLYMER STP-EP-HV** was conducted in 2 steps: pre-coating of edges, ventilation screens and blades was passed with brush or roller to increase the total layer thickness in these sensible zones. Following, the coating was applied by airless spraying with a thickness of 350 µm. The curing time was also 20 hours at a room temperature of 20 °C.
